## Chapter 9

# FIRE BEHAVIOR IN WORLD TRADE CENTER 2

### 9.1 INTRODUCTION

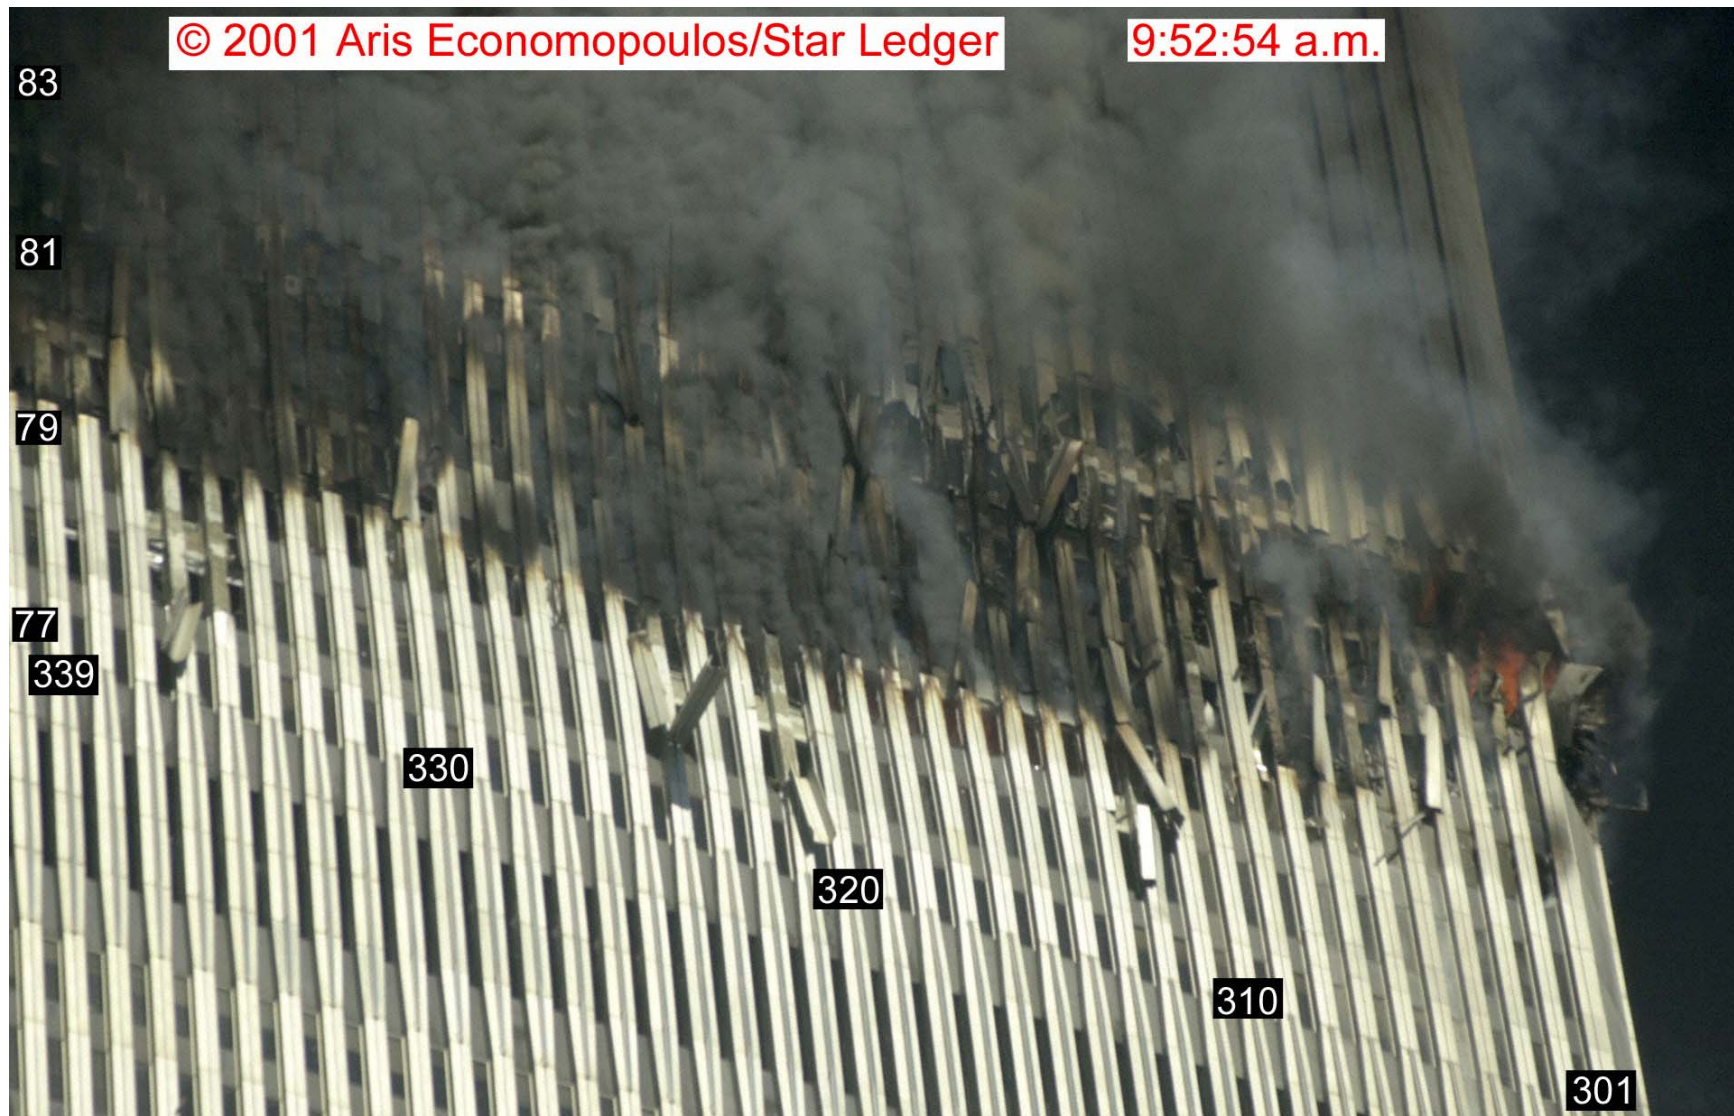
Figure 9-80. This cropped photograph shows a view of the east face of WTC 2 at 9:52:54 a.m. The intensity levels have been adjusted, and column and floor numbers have been added.

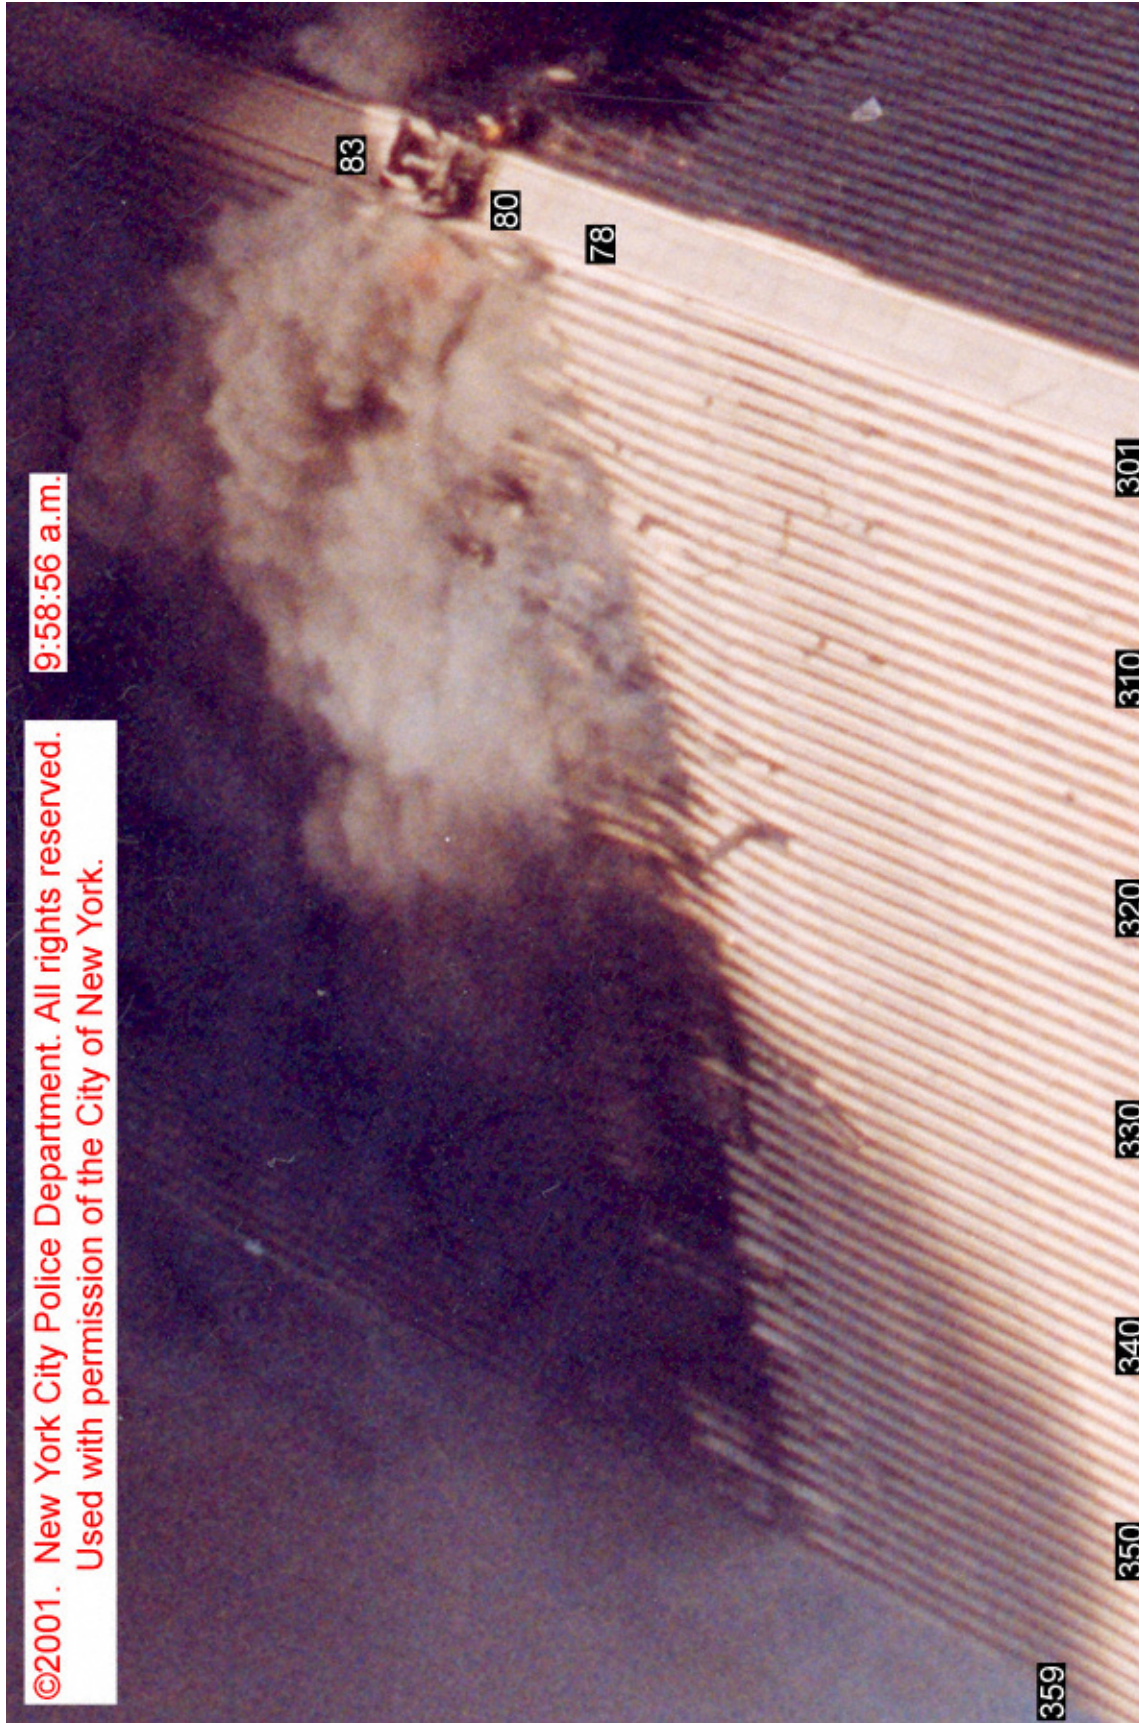
Figure 9-83. This cropped image shows the east face of WTC 2 at 9:58:56 a.m. The intensity levels have been adjusted, and column and floor numbers have been added.
